# The North Bellarine Beach Access and Feasibility Study

## Commissioned for Bellarine Bayside

28 August 2025

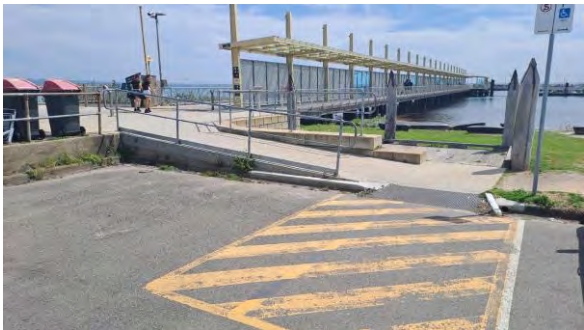
| Category | Description | Example |
|---|---|---|
| Very high | Fully accessible beach access with continuous universal access to sealed path or boardwalks, well signed, adjoining formal parking, catering for large catchment or major visitor node. | |

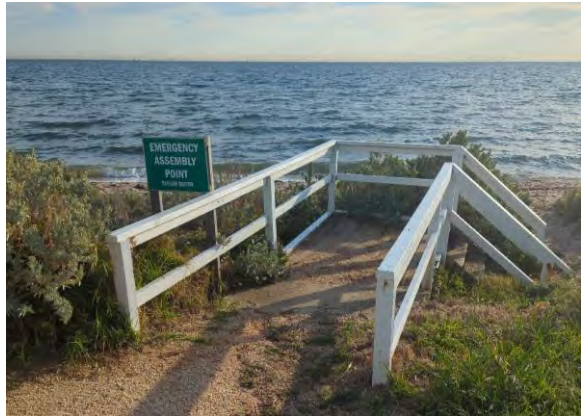
| Category | Description | Example |
|---|---|---|
| High | Formalised with sealed path with high levels of supporting infrastructure and well-maintained grounds. | |

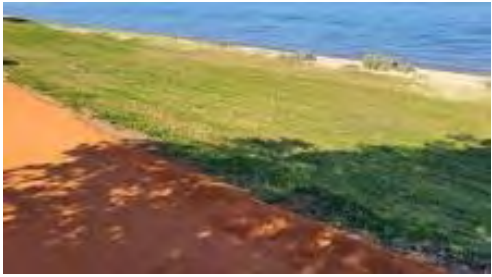
| Category | Description | Example |
|---|---|---|
| Open Beach Access | Maintained grassed areas. Typically associated with caravan park frontages but not limited to, and unrestricted by fences and vegetation. | |

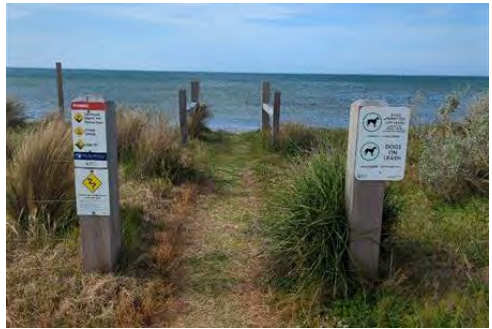
| Category | Description | Example |
|---|---|---|
| Mid | Formalised path, typically with basic signage. | |

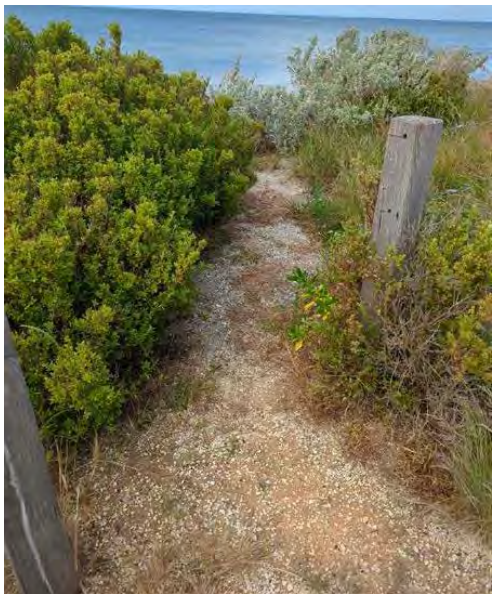
| Category | Description | Example |
|---|---|---|
| Basic | Consists of basic tracks with minimal infrastructure, typically no signage, no adjoining facilities. | |

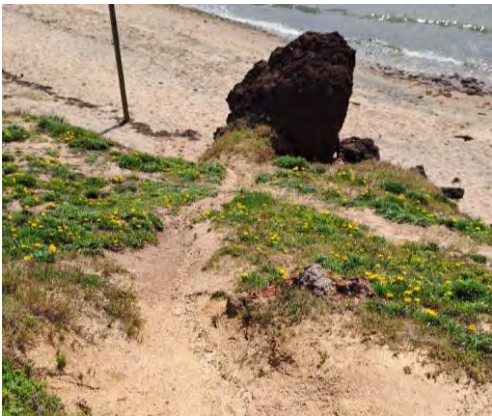
| Category | Description | Example |
|---|---|---|
| Very Basic | Informal beach access tracks. With no infrastructure, no signage and no adjoining facilities. | |

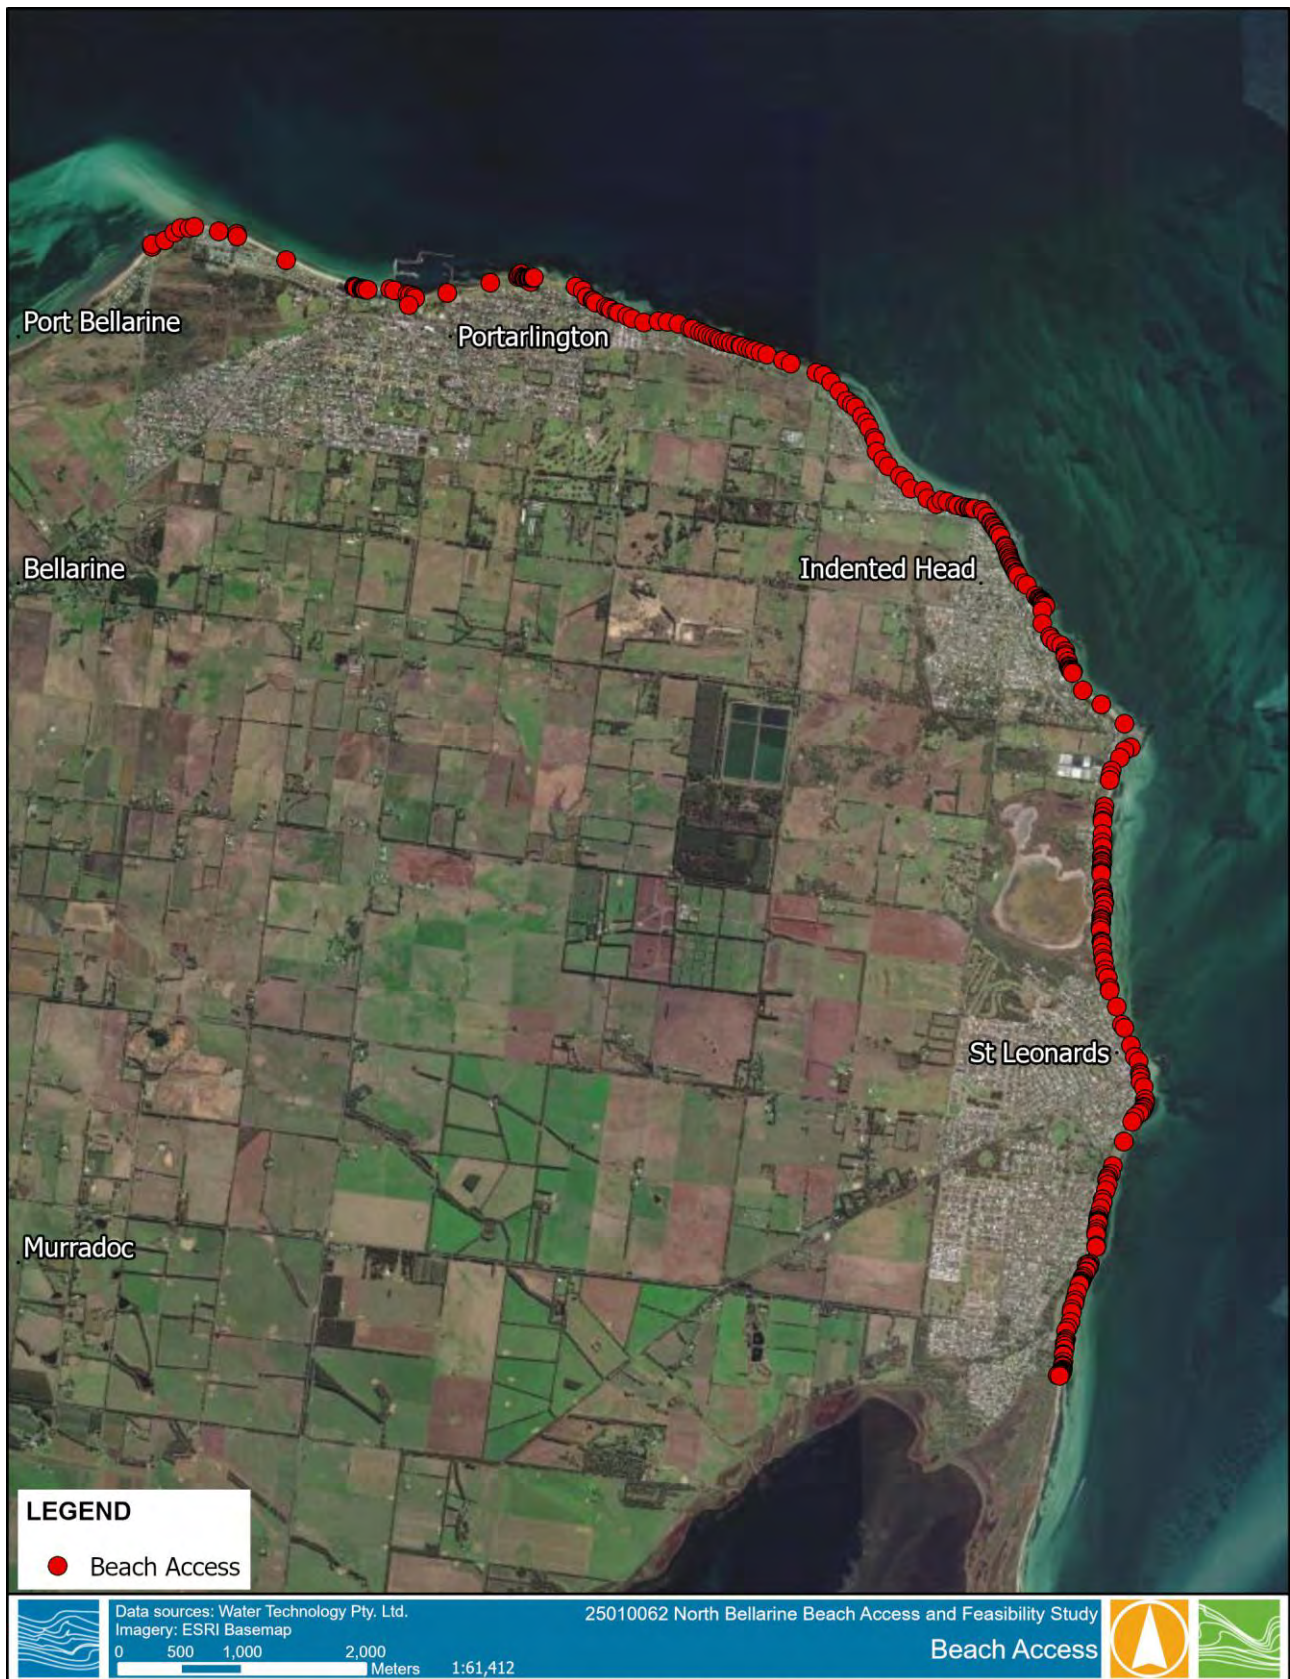
**Figure 2-1 Beach access database**

Water Technology carried out an in-depth field audit of beach access along the 17 km of coast from Point Richards through to Beach Road on 21/10/2024 and 22/10/2024. A database was produced that assessed, described and categorised the access points. The field audit methodology is provided in greater detail in the Audit Report (Water Technology 2024). In summary the audit assessed each access based on:

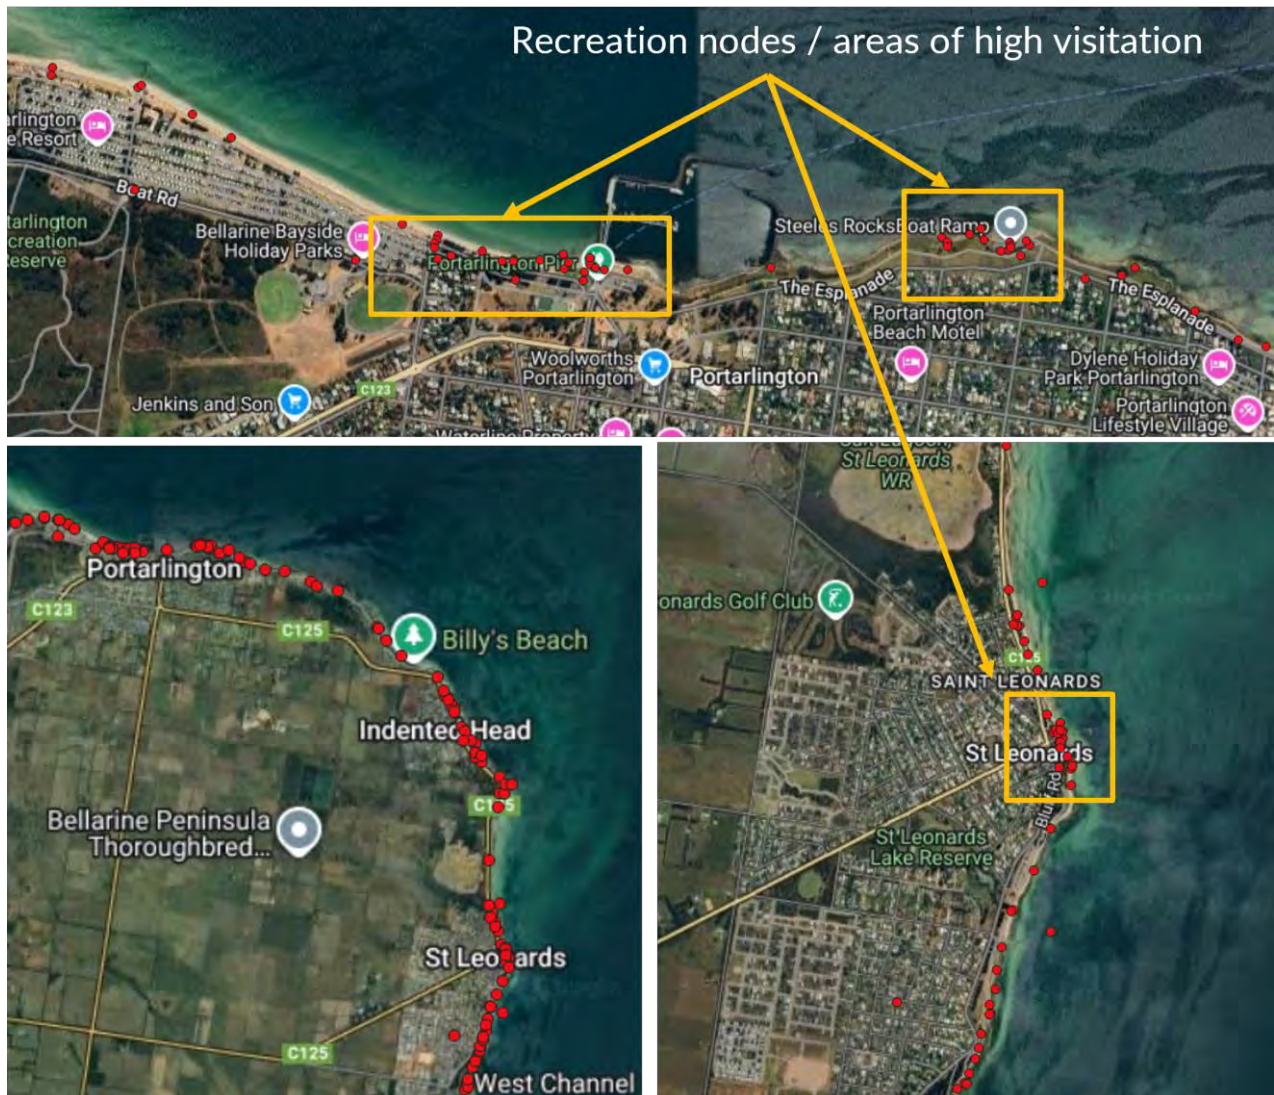
Figure 3-4 Access points used by the public

The consultation returned visitation location data, shown in Figure 3-4. From this data, high visitation location areas are identified, indicated by areas of point clustering.

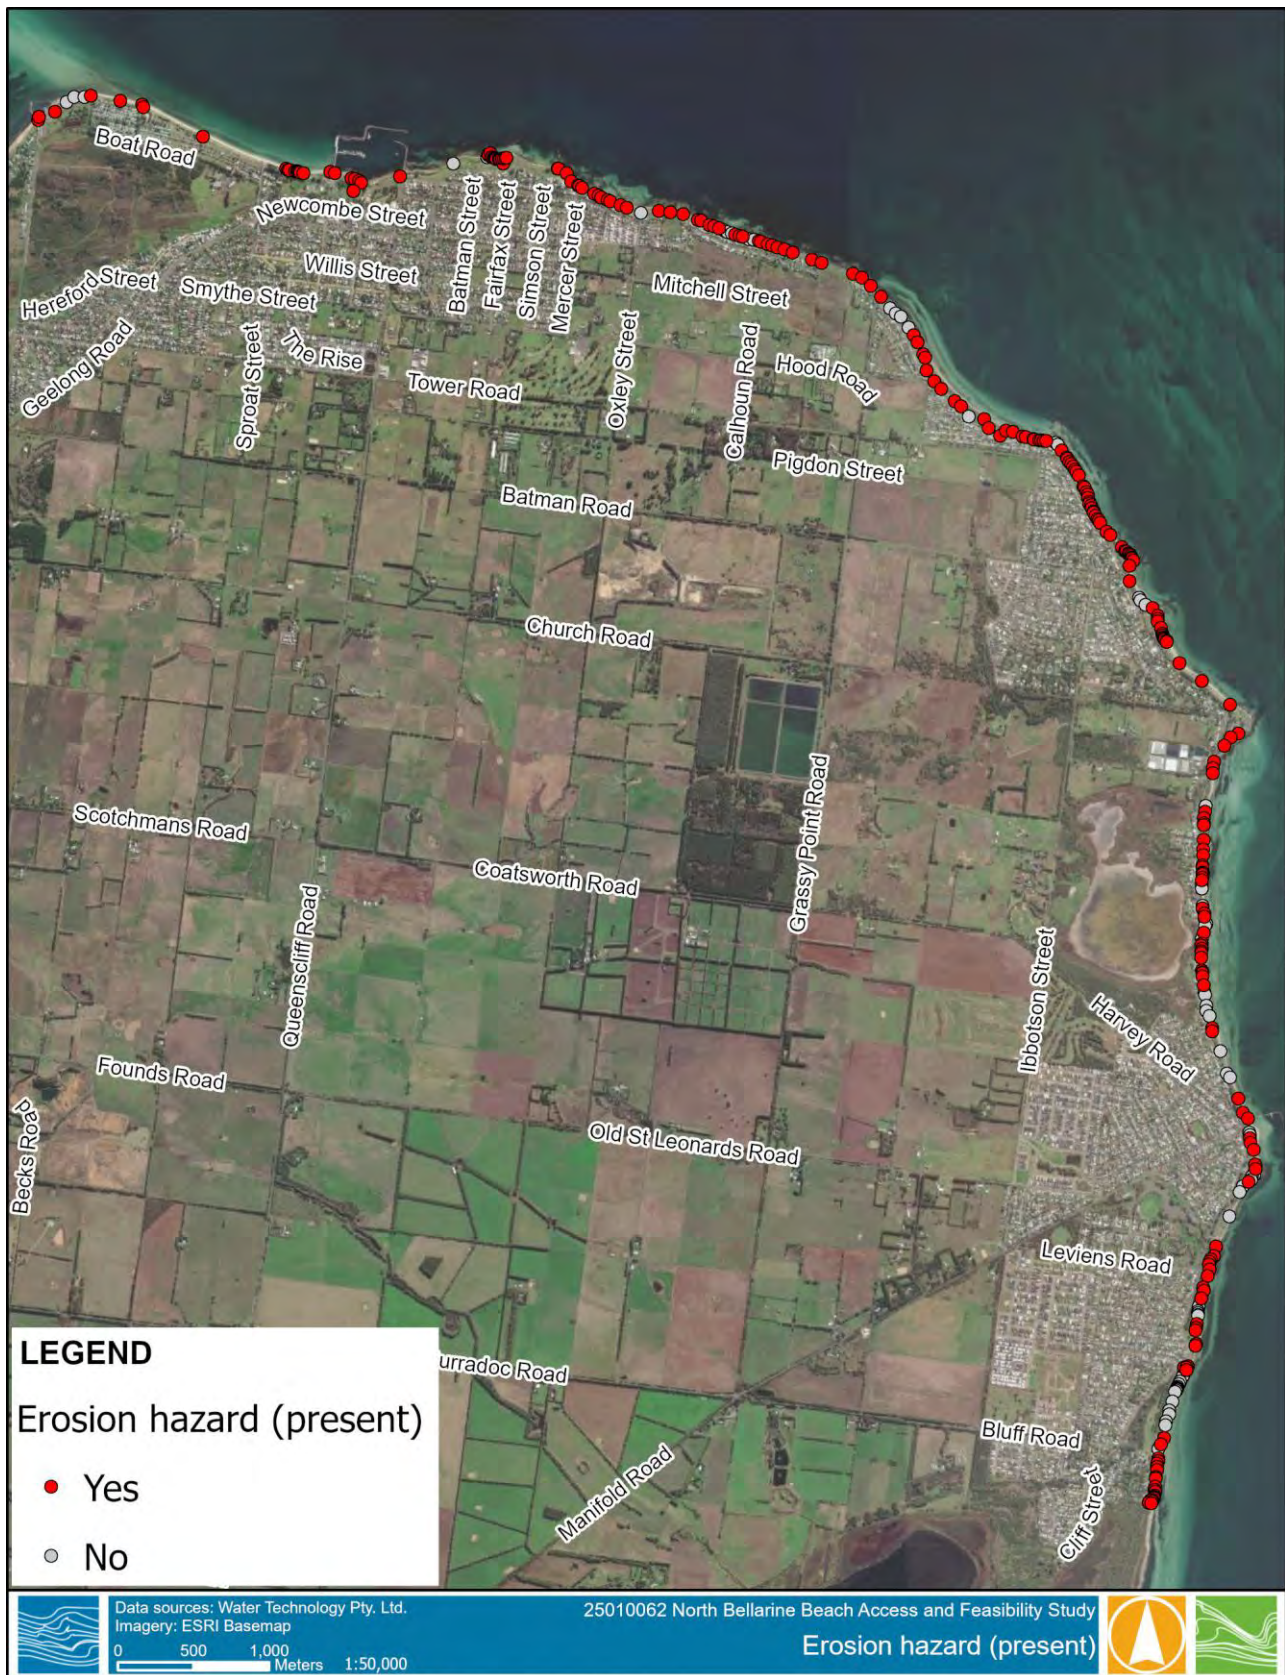
Analysis of the access points against the 1% AEP present day erosion hazard extent found **78%** of the access points are expected to be impacted by coastal erosion (Figure 4-3).

**Figure 4-3 Beach Access vulnerable to erosion hazard in present day 1% AEP storm**

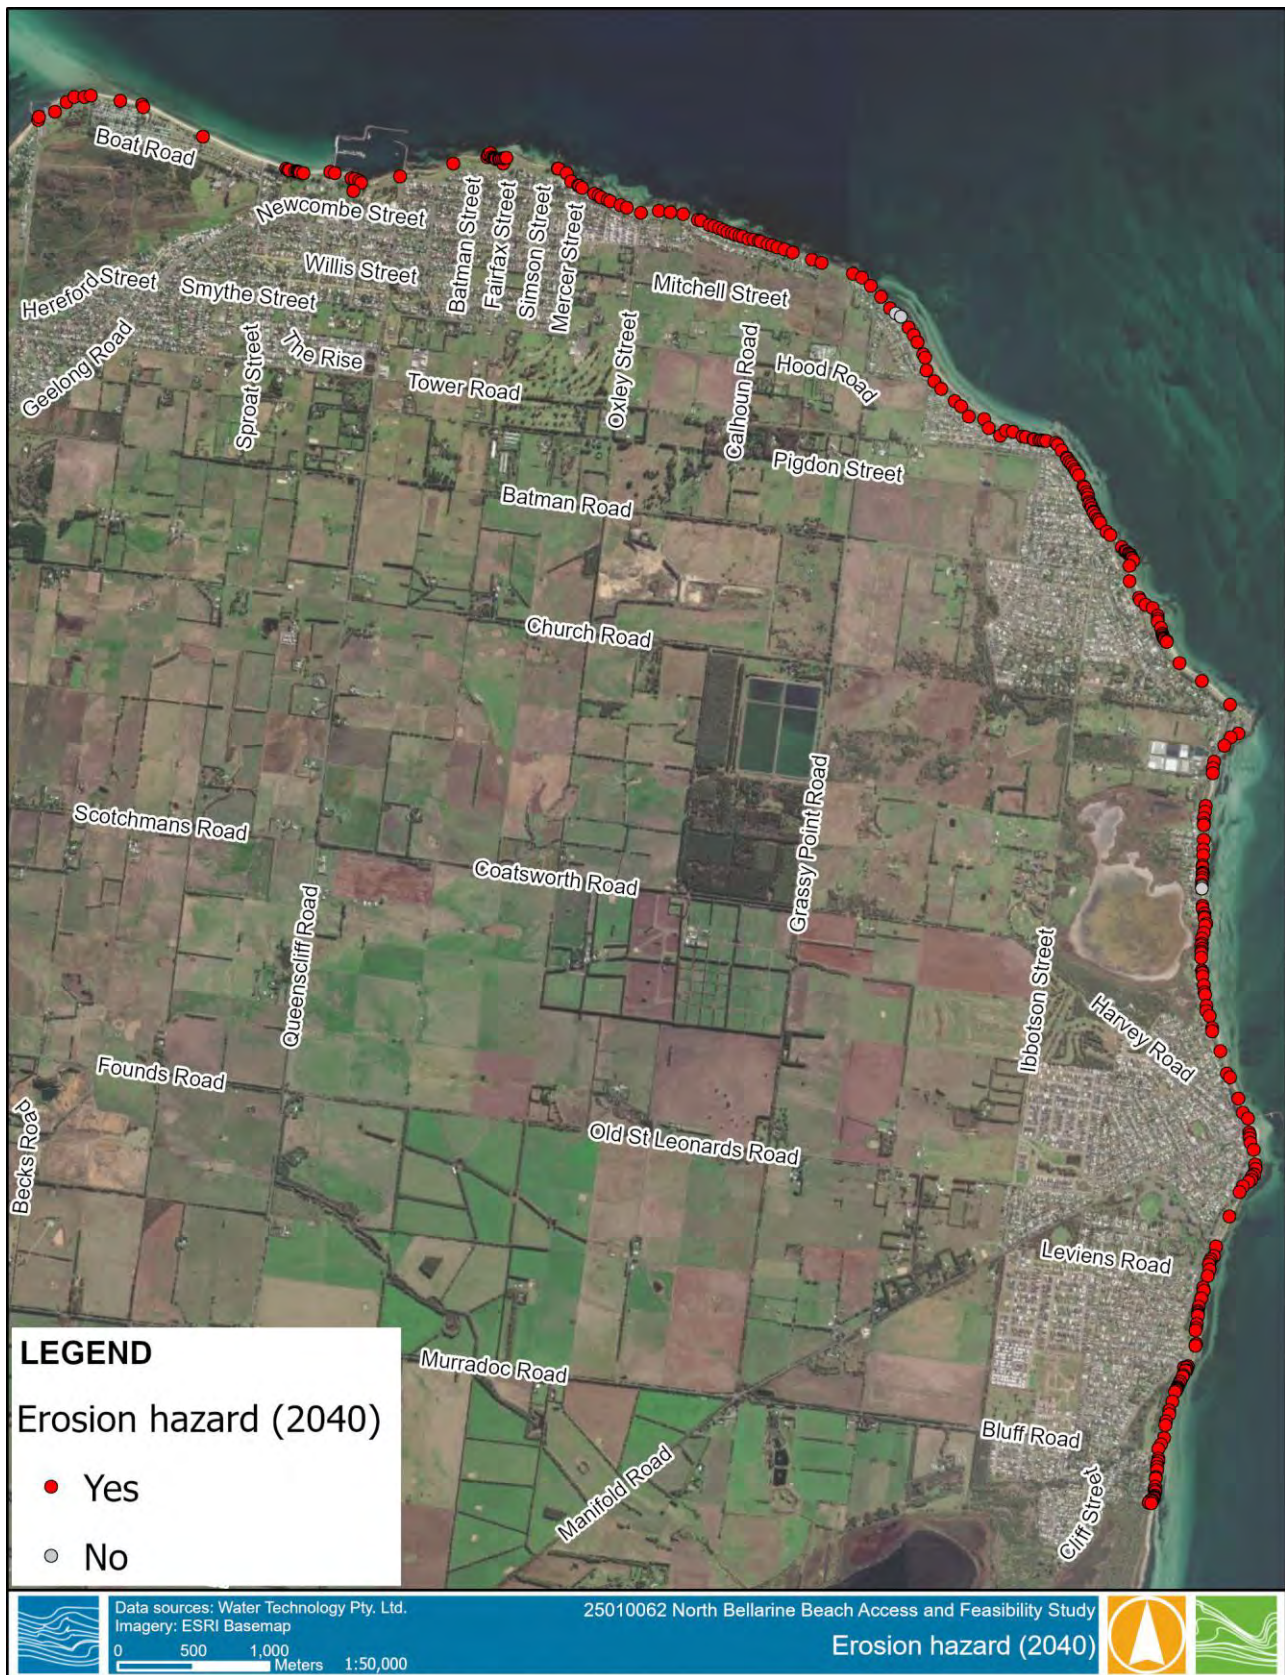
Analysis of the access points against the 1% AEP by 2040 erosion hazard extent found **99%** of the access points are expected to be impacted by coastal erosion (Figure 4-4).

Figure 4-4 Beach Access vulnerable to erosion hazard in 2040 1% AEP storm

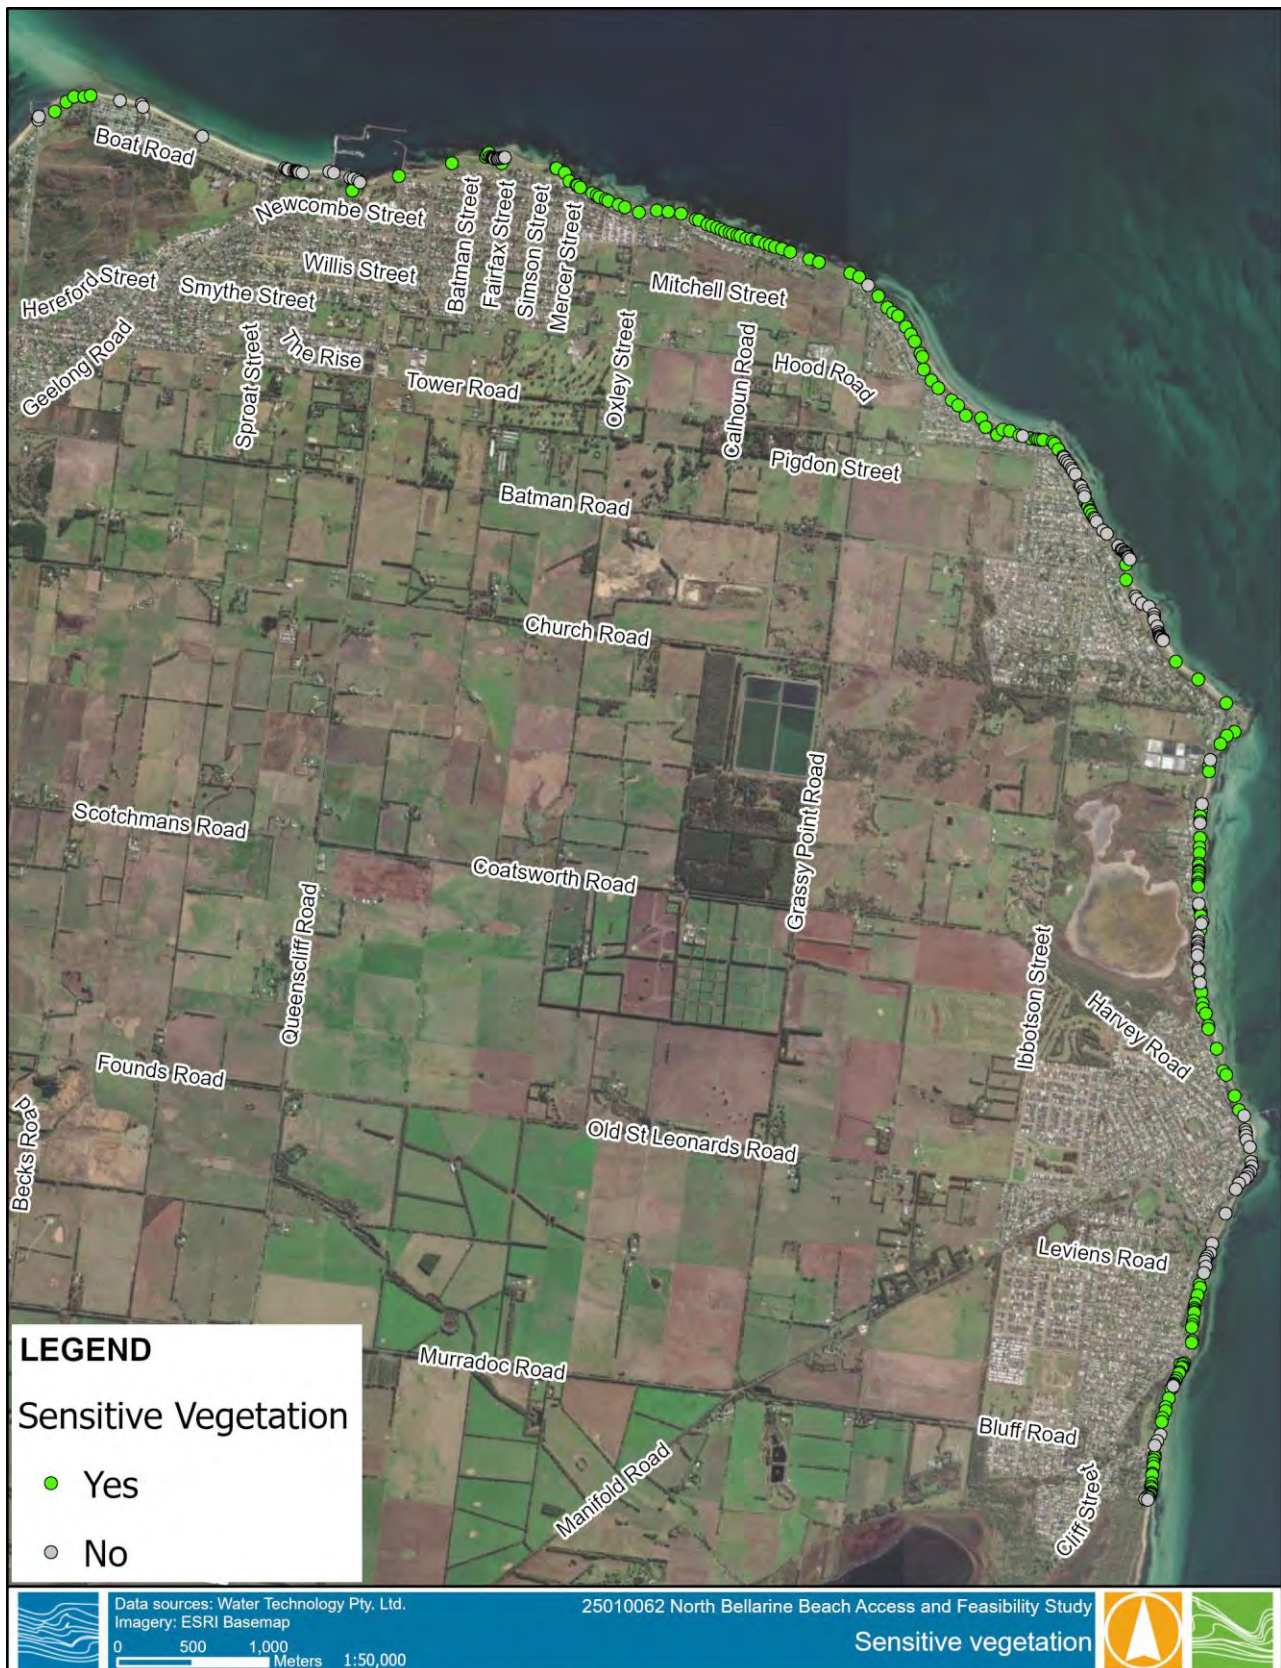
Analysis of the access points against the sensitive vegetation database found **61%** of the access points are within areas containing sensitive vegetation and may have an impact on the sensitive vegetation (Figure 4-5).

Importantly, the vegetation has not been fully mapped in areas where the remaining **39%** of access points exist, therefore, there may be a higher number of beach access points having an impact on sensitive vegetation than recorded in this study.

**Figure 4-5 Beach Access points within sensitive vegetation areas**

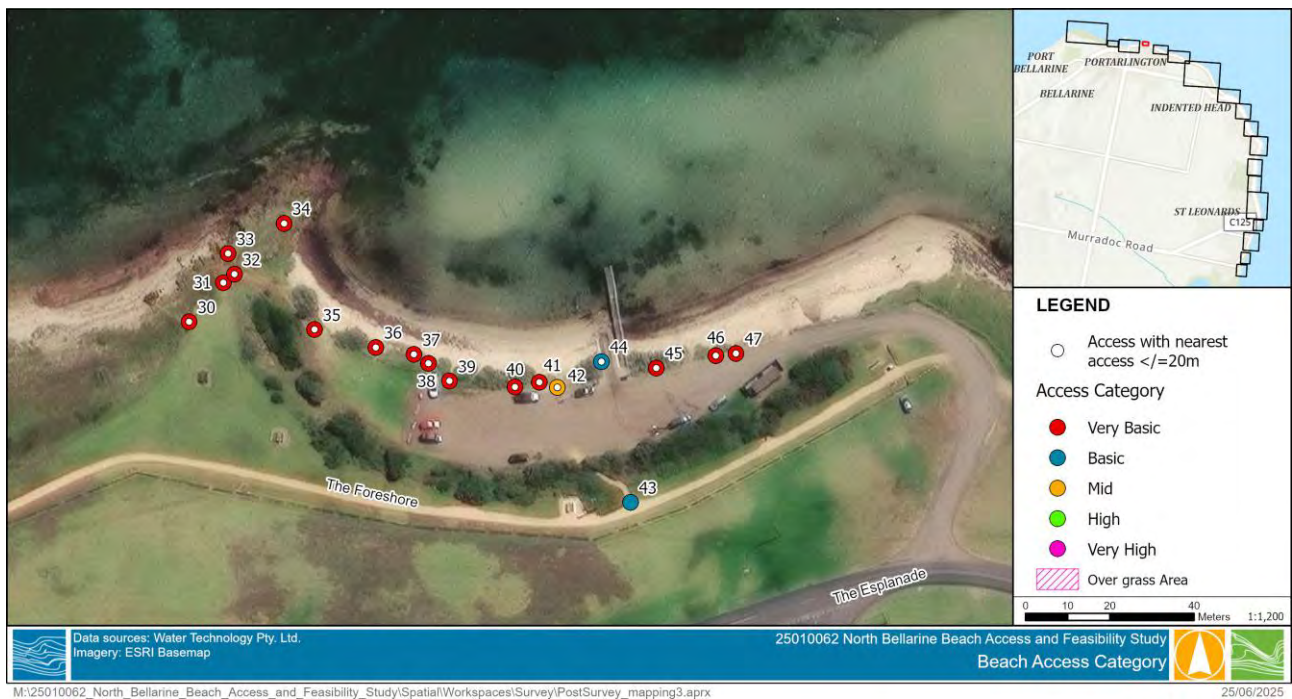
The Beach Access Audit revealed a trend of access clustering, whereby a little over half of the beach access points have neighbouring access within 20 m and approximately one third of the beach access points have an alternative access within 20 to 50 m (shown in Figure 5-1). Examples of the clustering are provided in Figure 5-2 to Figure 5-4, indicated by the white dots in the location points.

Figure 5-2 Example 1 of access clustering (Steeles Rocks, Portarlington)

Therefore, it is not deemed feasible to close off all informal tracks. Instead, it is recommended to target areas of high density ('clustering') of informal tracks and consolidate access to regularly spaced designated access tracks centred around key activity nodes.

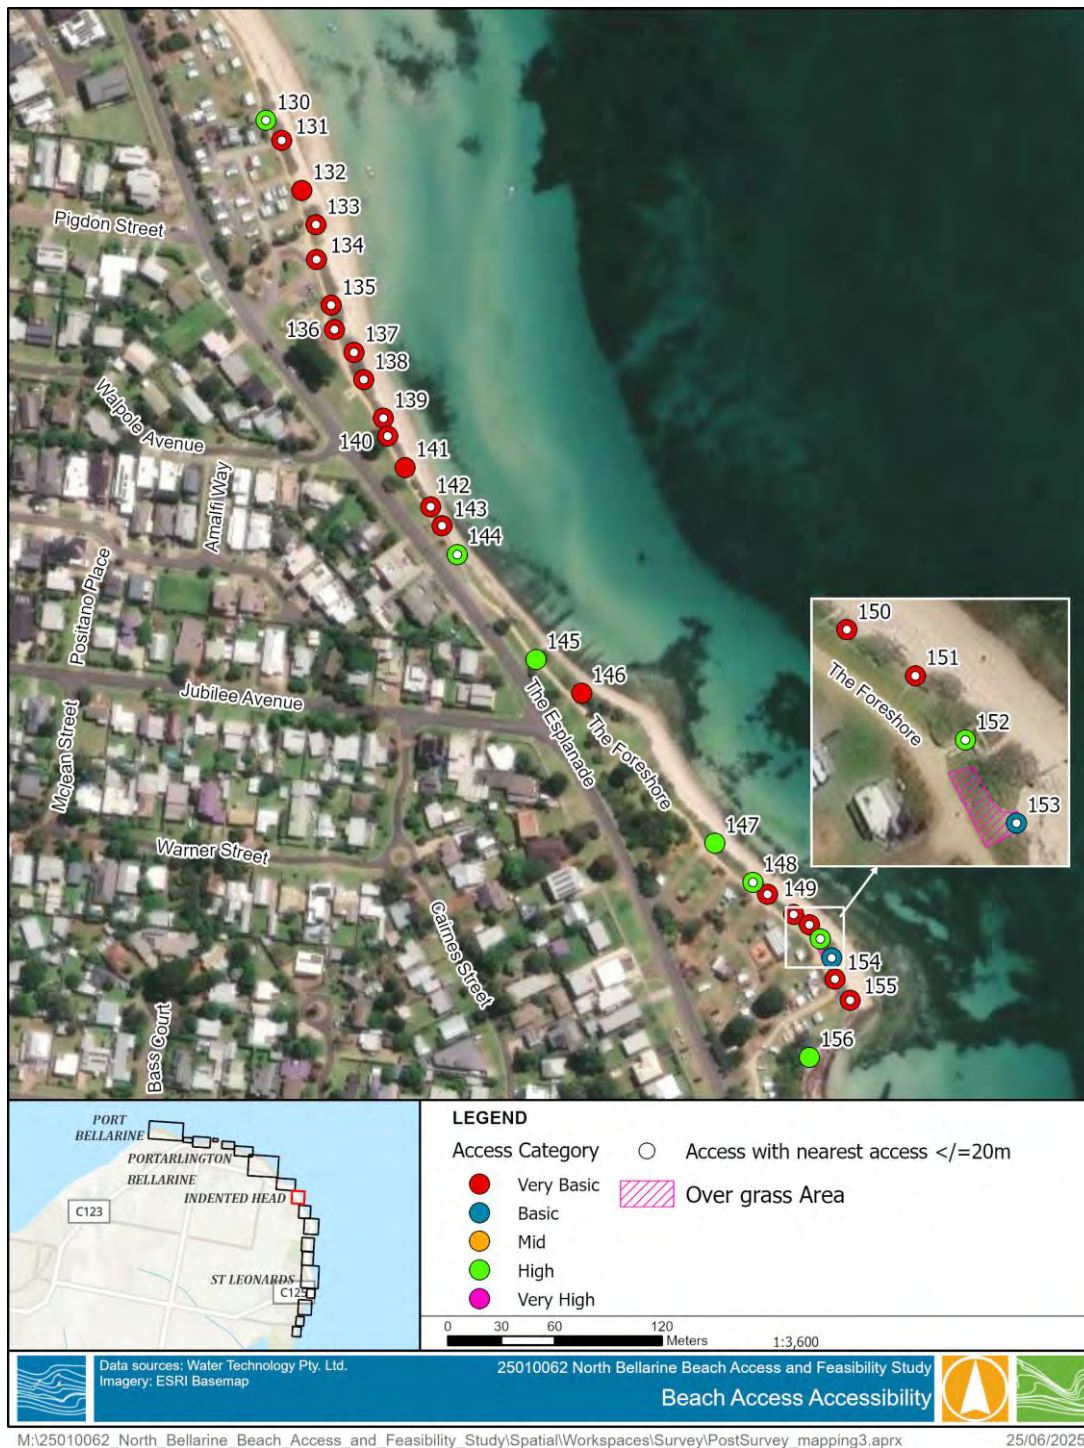
Figure 5-3 Example 2 of access clustering (Indented Head)

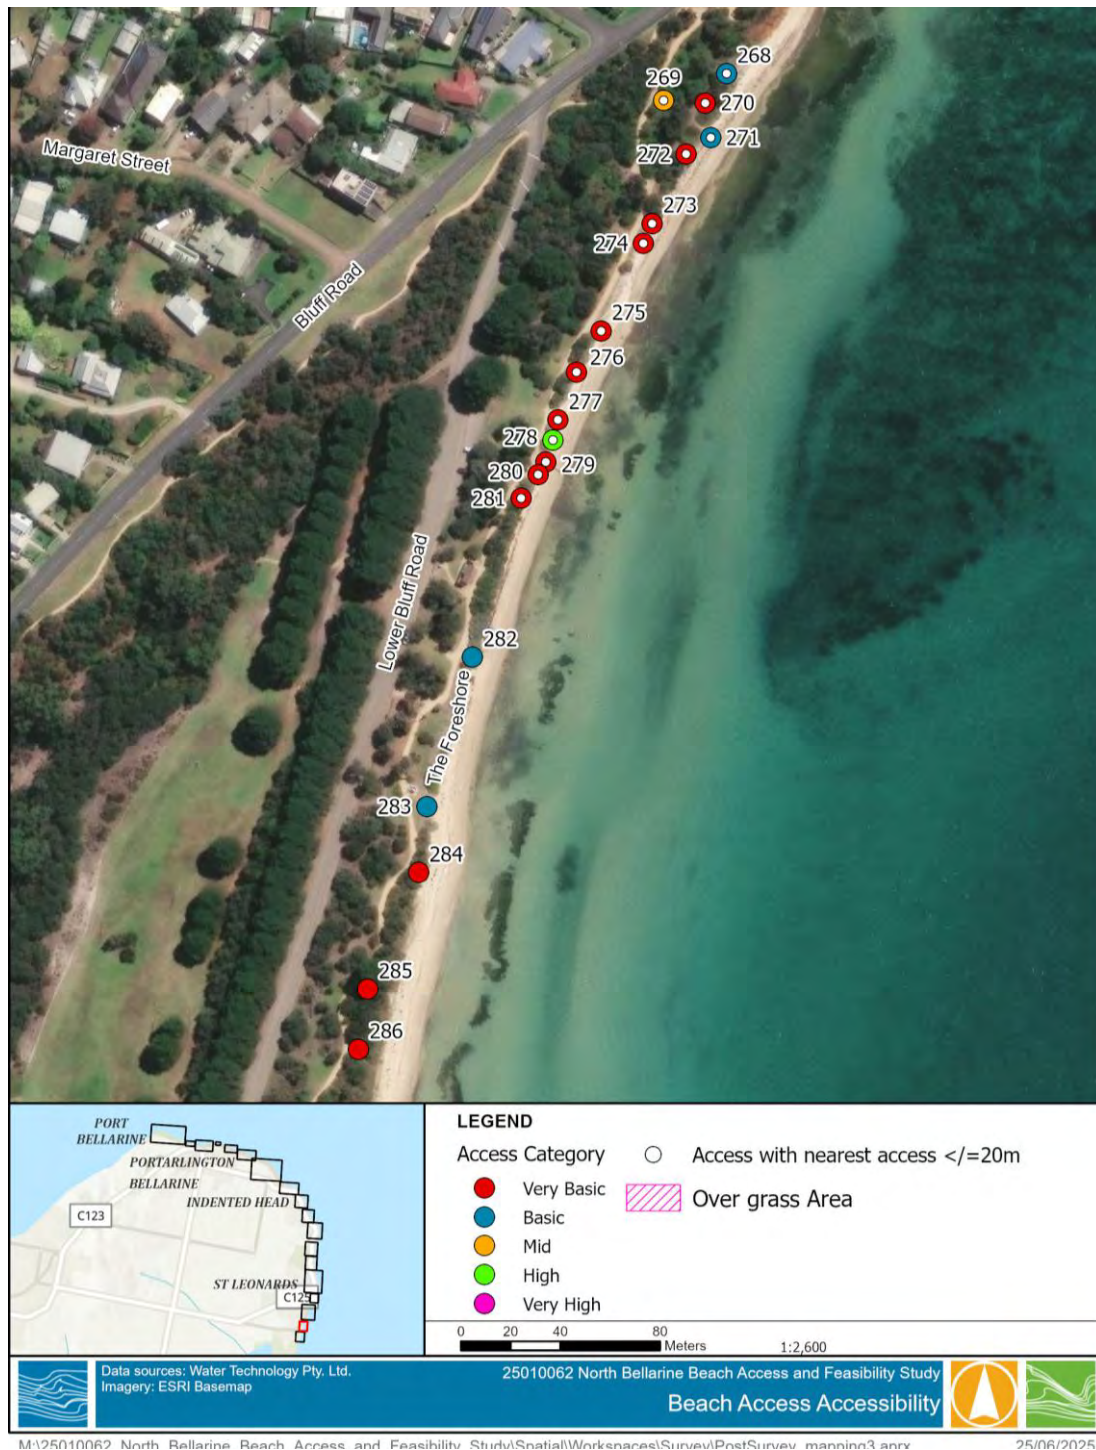
**Figure 5-4 Example 3 of access clustering (Lower Bluff Rd, St. Leonards)**

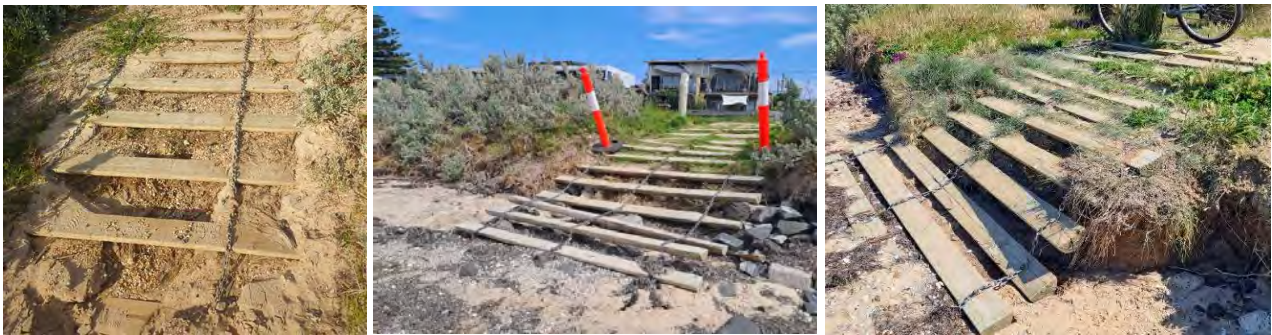
The field audit noted that most sand ladders had been compromised by scarp erosion beneath leaving the asset unsupported and a hazard to public, examples are shown in Figure 6-1. Such safety concerns were raised via community consultation. Since the audit, Bellarine Bayside have carried out works to shorten these structures to reduce the risk of injury. However, it is recommended that these structures be regularly maintained to improve safety in the short term and are considered for upgrade in future planning.

Figure 6-1 Erosion undermining of sand ladders – safety issue

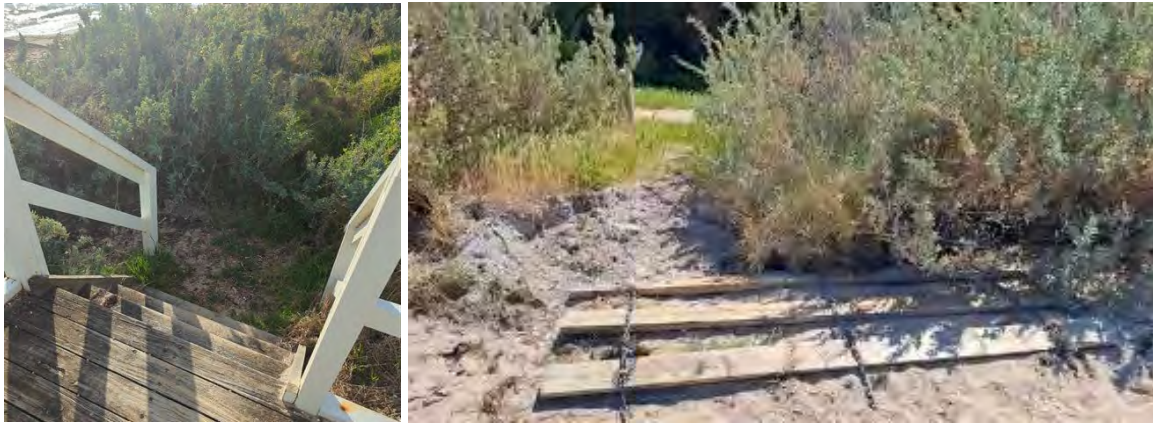
Concerns were raised through community consultation regarding safety of overgrown vegetation at beach access points. An example of overgrown vegetation is given in Figure 6-2. This presents an opportunity to support improved safety outcomes by facilitating sustainable management of beach access and enabling regular maintenance and monitoring.

**Figure 6-2 Overgrown vegetation**

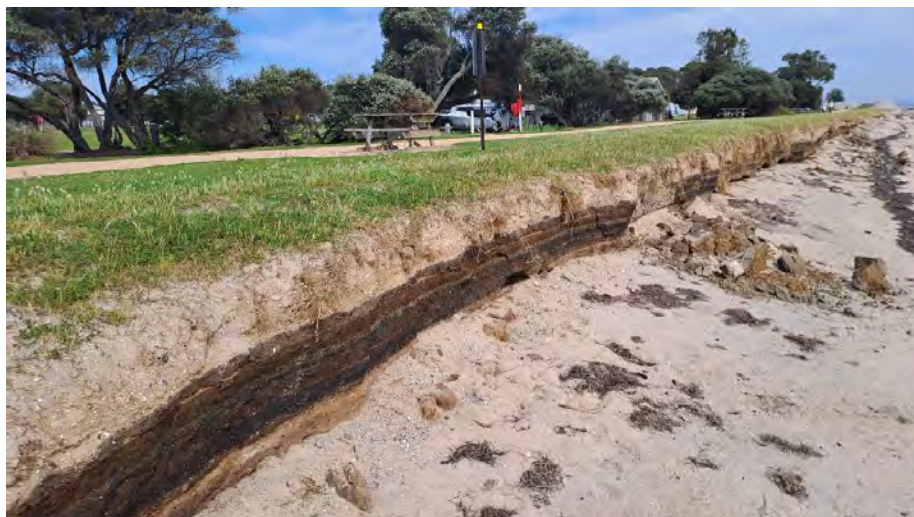
The field audit noted that multiple access points were impacted by erosion scarps at the back of the beach (example given at Portarlington Holiday Park in Figure 6-3). These were likely caused by a spell of high wind and wave conditions two months prior to the audit. Bearing in mind that the audit is a single snapshot in time and erosion scarps are the result of a natural process whereby sand is temporarily moved offshore in high wave conditions. This sand typically returns onto the beach during calmer wave conditions. Therefore, from a risk perspective, erosion scarp is considered temporary and is mitigated overtime by natural processes. The risk is lowered over time as the sand returns to the beach, raising beach levels and reducing the scarp height and therefore risk to the public. Where particularly steep erosion scarp occurs, signage or temporary fencing to warn beach-goers may reduce the risk of accidents.

**Figure 6-3 Beach erosion scarp**

It is recommended that a set of guidelines are created to address and access erosion scarps. Parameters should be logged, such as a threshold height that triggers intervention. Intervention may involve options such as renourishment up to the scarp or manual reduction via reprofiling of the upper beach and signage as mentioned above.

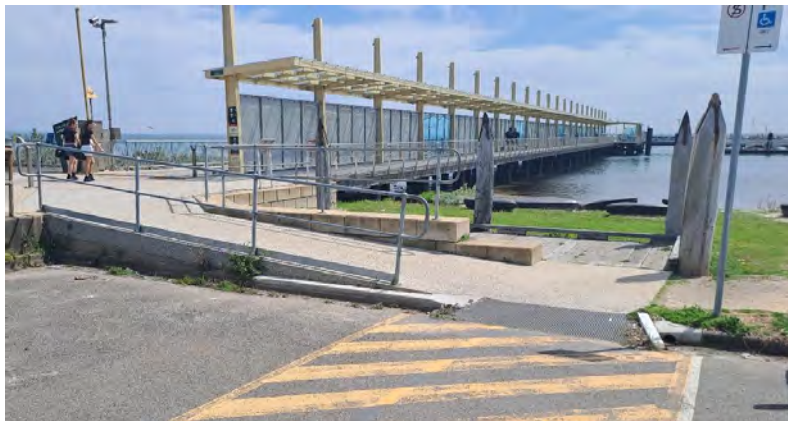
The access audit noted two *Very High* category access points along the study area that provide universal access, located at Portarlington Pier (presented in Figure 6-4) and opposite Coach Road, between Indented Head and Portarlington (presented in Figure 6-5).

Figure 6-4 All Abilities access at Portarlington Pier

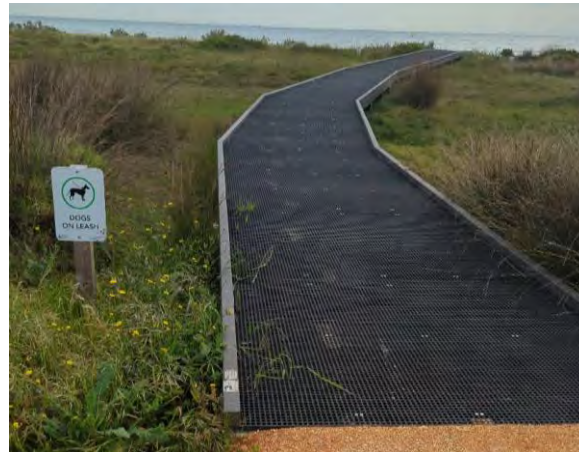
**Figure 6-5 All Abilities access north of Indented Head near Coach Road**
