# ANDERSON RESERVE GROYNES

## Functionality Review

BMT was engaged by Bellarine Bayside, in partnership with The Department of Energy, Environment and Climate Action (DEECA), in 2024 to review the functionality of the groynes built at Anderson Reserve in response to community concern that the groynes were having a negative impact on surrounding beaches.

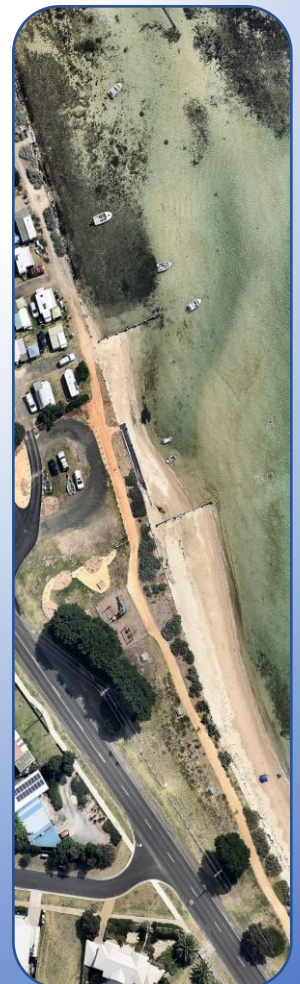
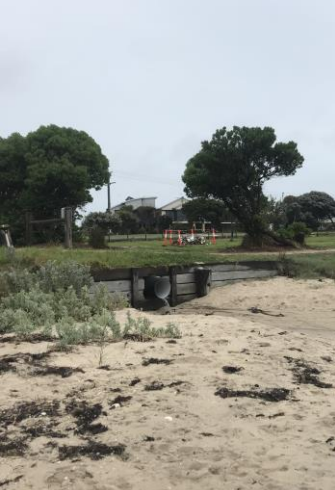
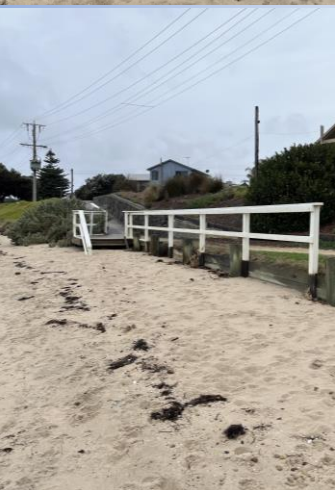
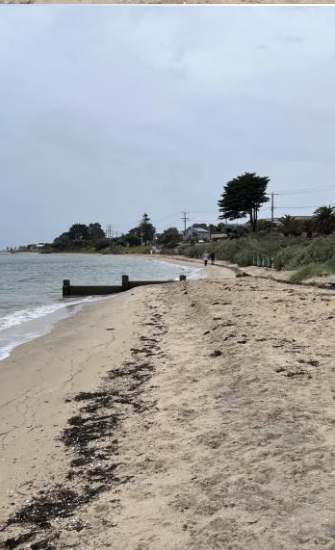
Groynes work by trapping sand moving along-shore and creating a wider beach, which acts as a buffer against storm erosion. Sand builds up in between the groynes and on the up-drift side of the groynes (direction the sand is coming from). There may be a corresponding reduction in beach sand on the down-drift side. At Anderson Reserve, the direction of along-shore transport changes frequently and sand may build up, or erode, on either side of the groynes in response to the prevailing wind and wave patterns.

The review found the design of the groynes (length, height, spacing, material) is considered appropriate for their intended function, and consistent with Victorian practice.

So far, the groynes have been effective (in combination with sand nourishment) at maintaining a beach in front of Anderson Reserve and preventing further damage to the seawall and erosion behind the seawall.
